TEST REPORT

Ind. Ser. No. : 14-04-NEF-039
 Applicant : Qualtek Electronics Corporation
 Address : 7610 Jenther Drive Mentor, Ohio 44060 U.S.A.
 Products : Axial fans
 Model : FDA2-17238 · FDA2-17251 · FDA2-17255 series
 Quantity : 6 set
 Date of Receipt :
 Date of Testing : Reference : ETC's Report NO.12-05-NEF-026
 Test specification : IEC60529 Edition 2.1 2001-02
 Electronics Testing Center, Taiwan – Southern Taiwan
 Inspection Site : Industry Service Department
 (TAF Certification No:1161)
 Ambient Environment : IP5X Temp. 23 ± 1 °C , R.H. 52 ± 2 %
 IPX6 Temp. 24 ± 1 °C , R.H. 59 ± 2 %
 Testing Item : IP56M
 Test condition : See the following sheets
 Test result : PASS (Reference : ETC's Report NO.12-05-NEF-026)

Testing Item: IP56M

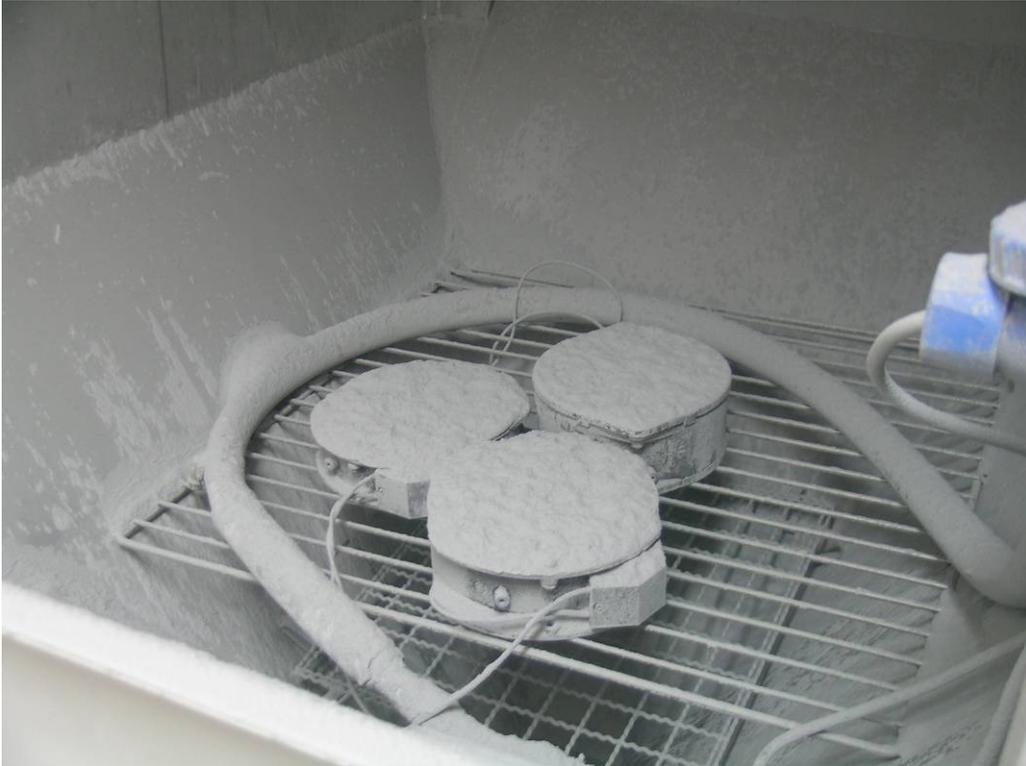
Axial fans : IP5X Test Photo

IP5X :

- (1) The enclosure under test is supported in its normal operating position inside the test chamber.
- (2) The test shall be continued for a period of 8h.

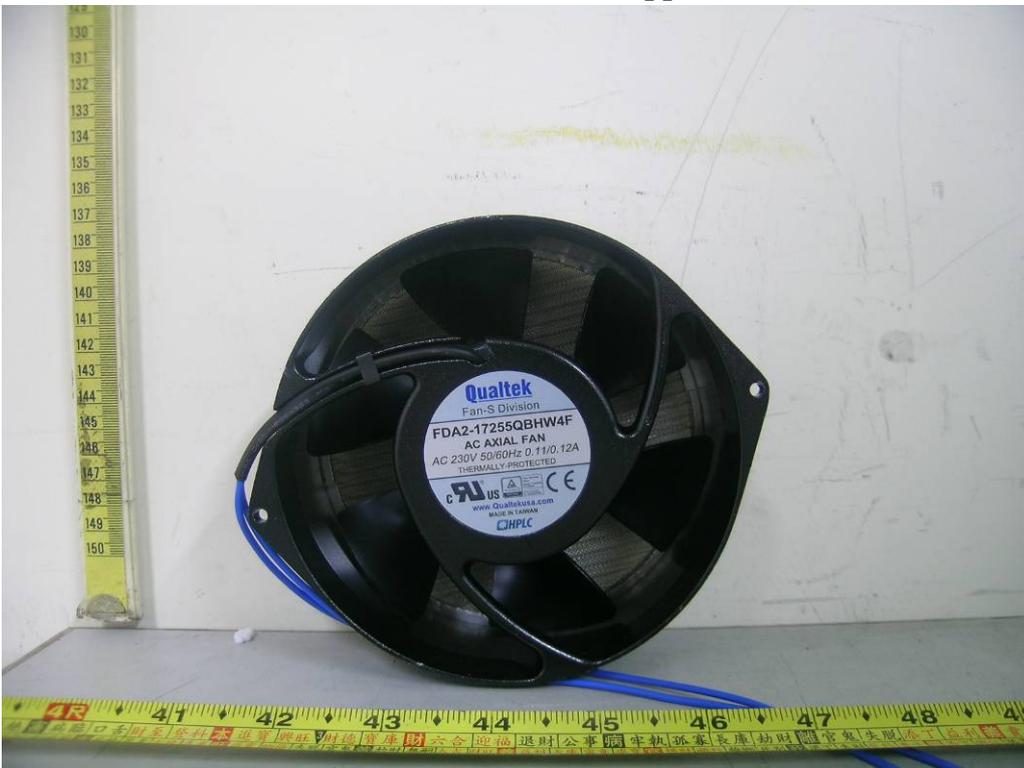
Axial fans (FDA2-17255) : Appearance

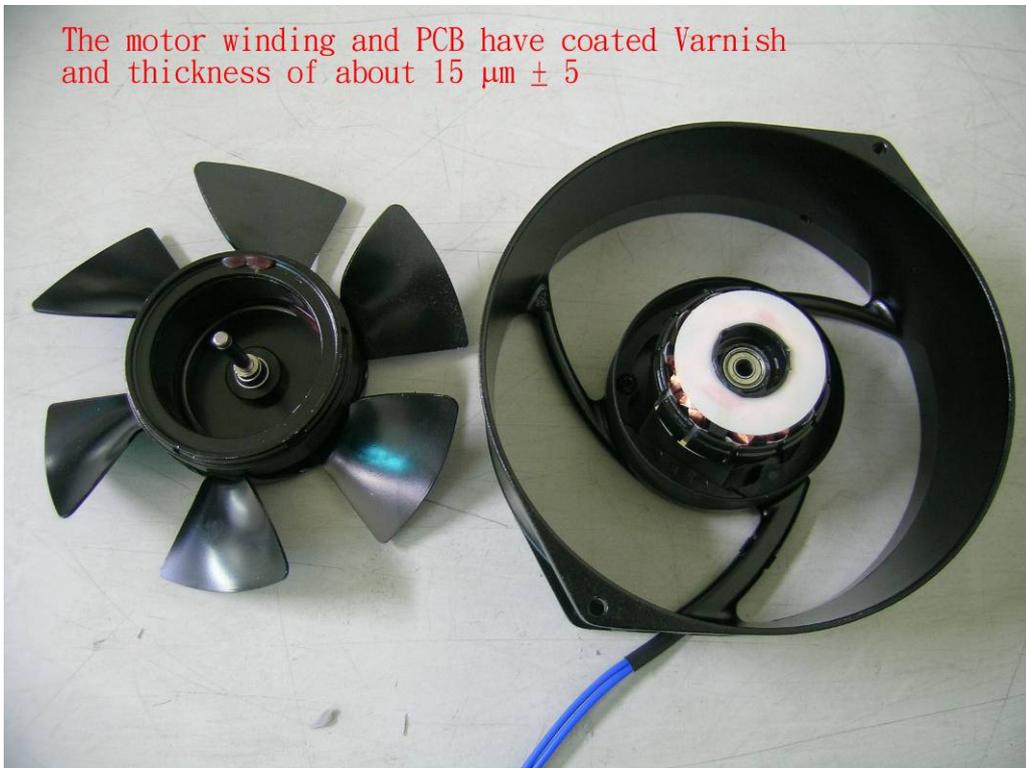
Axial fans (FDA2-17255) : Inside

The motor winding and PCB have coated Varnish and thickness of about $15 \mu\text{m} \pm 5$

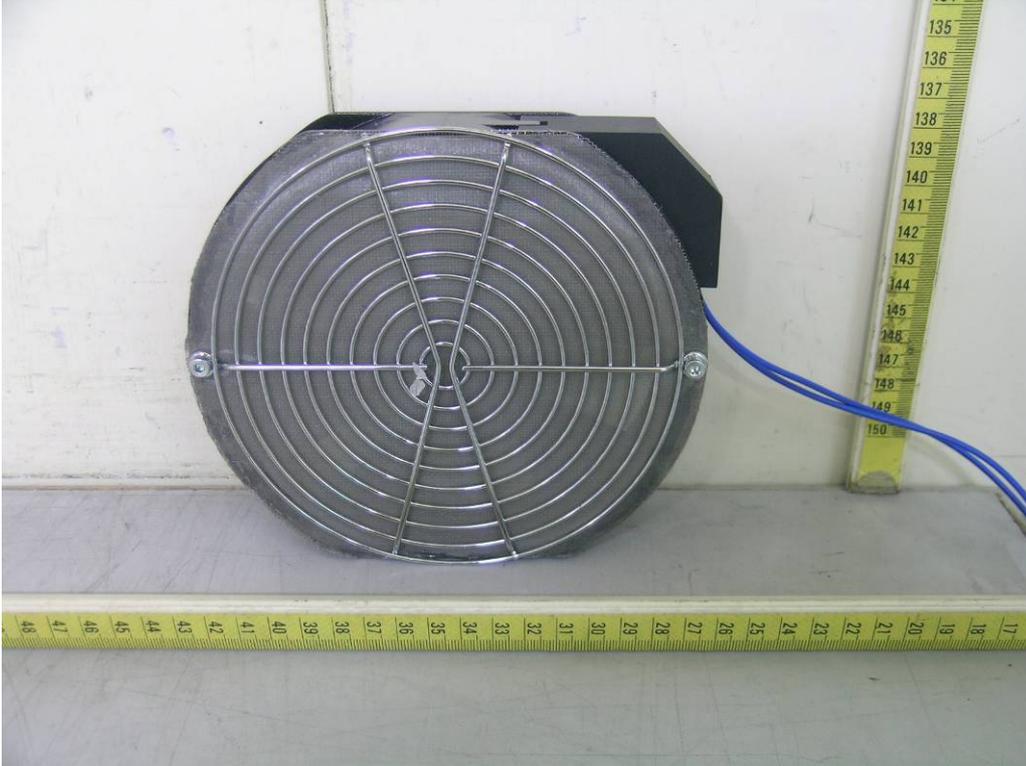
Axial fans (FDA2-17238) : Appearance

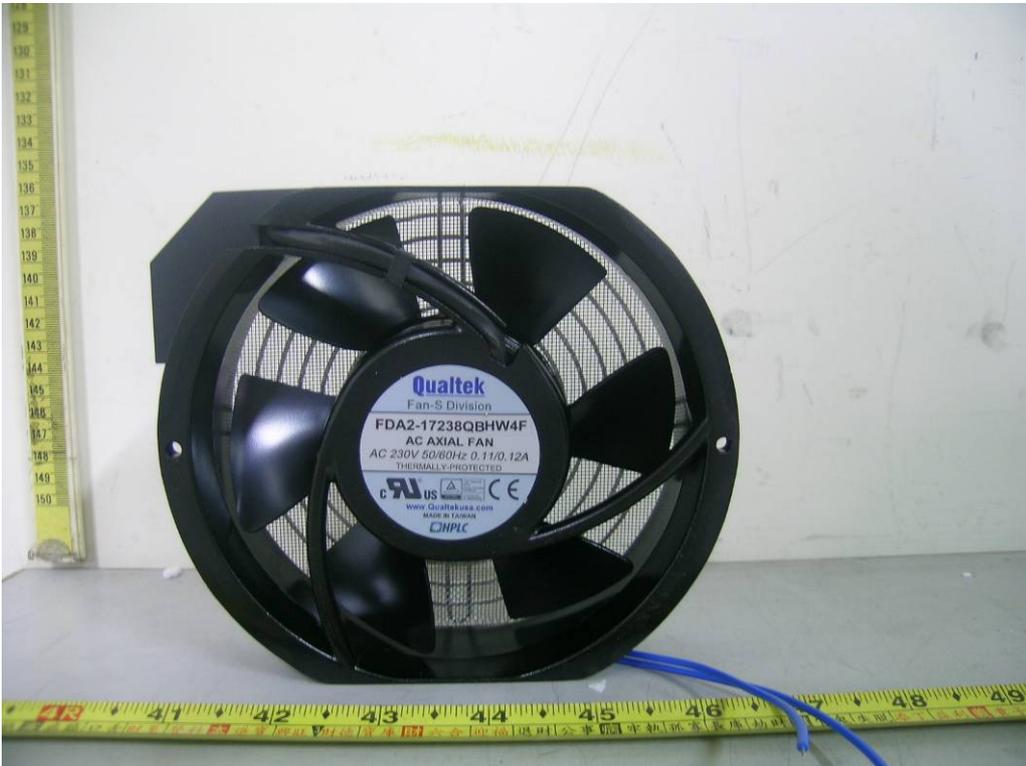
Axial fans (FDA2-17238) : Appearance

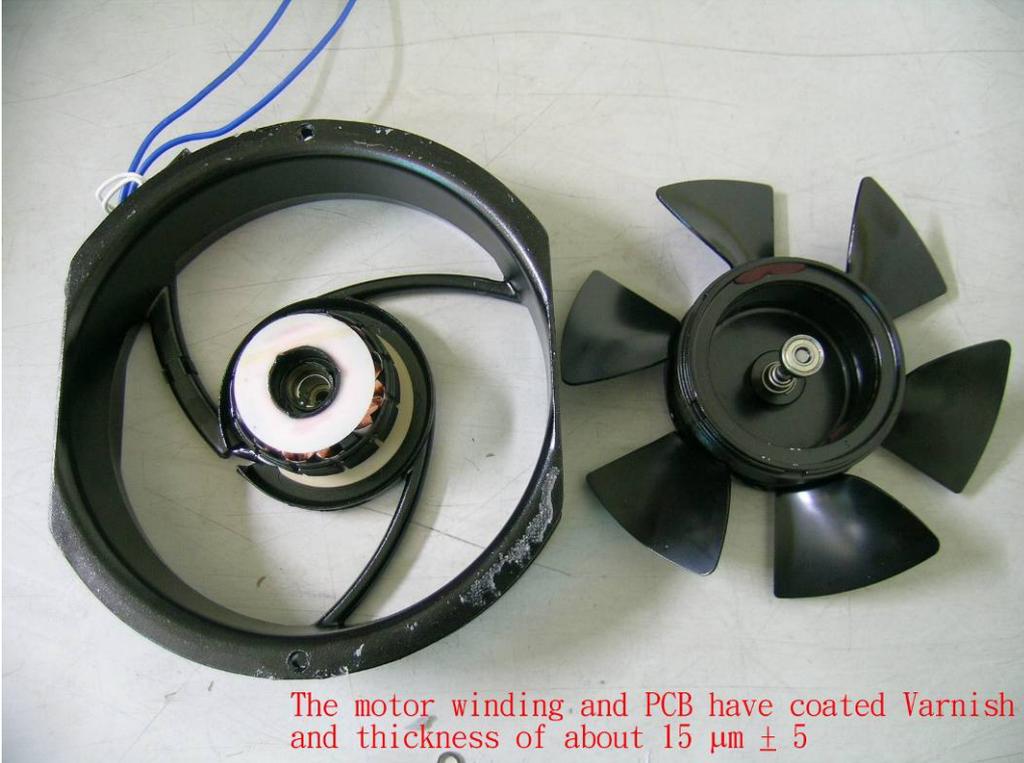
Axial fans (FDA2-17238) : Inside

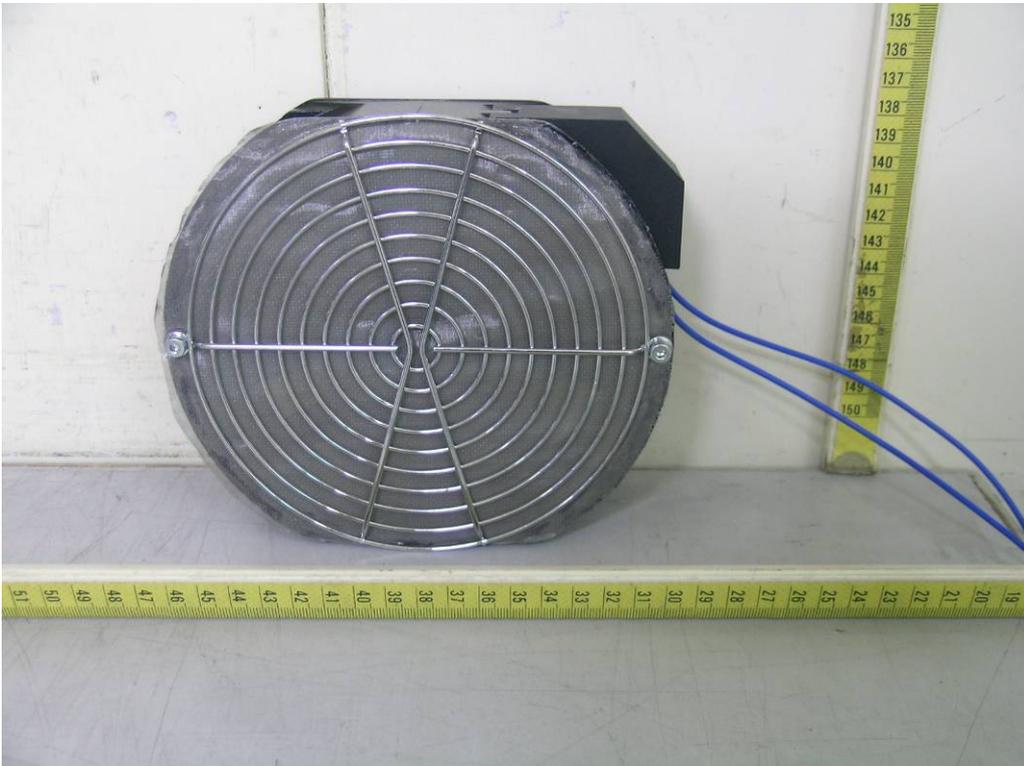
Axial fans (FDA2-17251) : Appearance

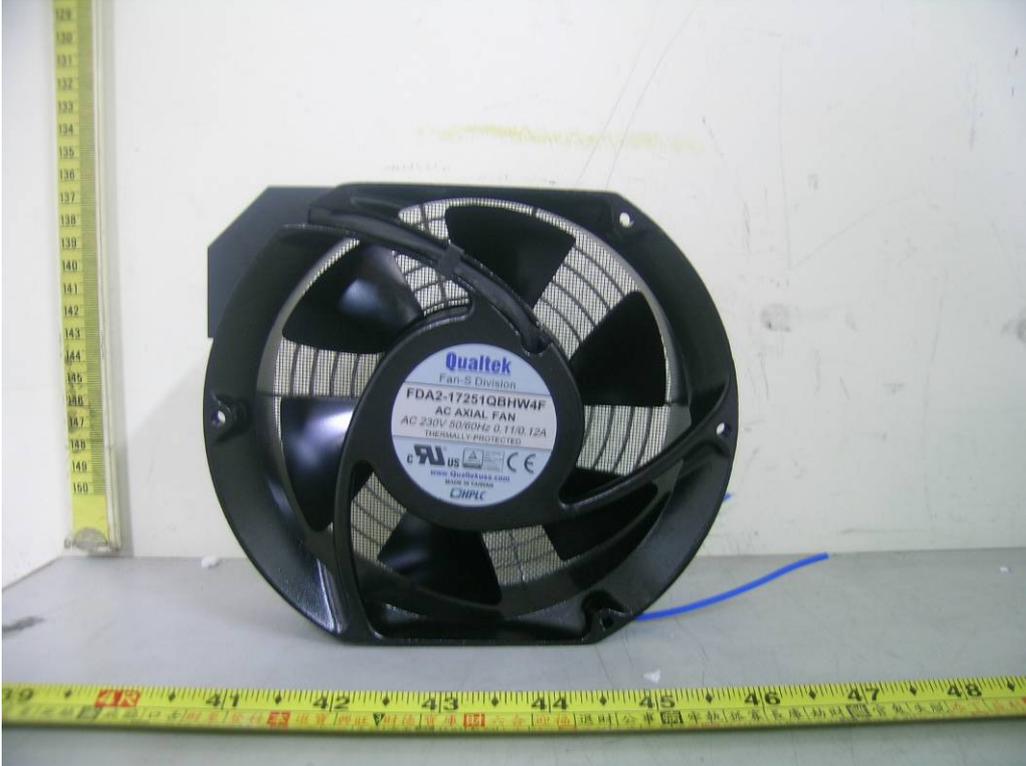
Axial fans (FDA2-17251) : Appearance

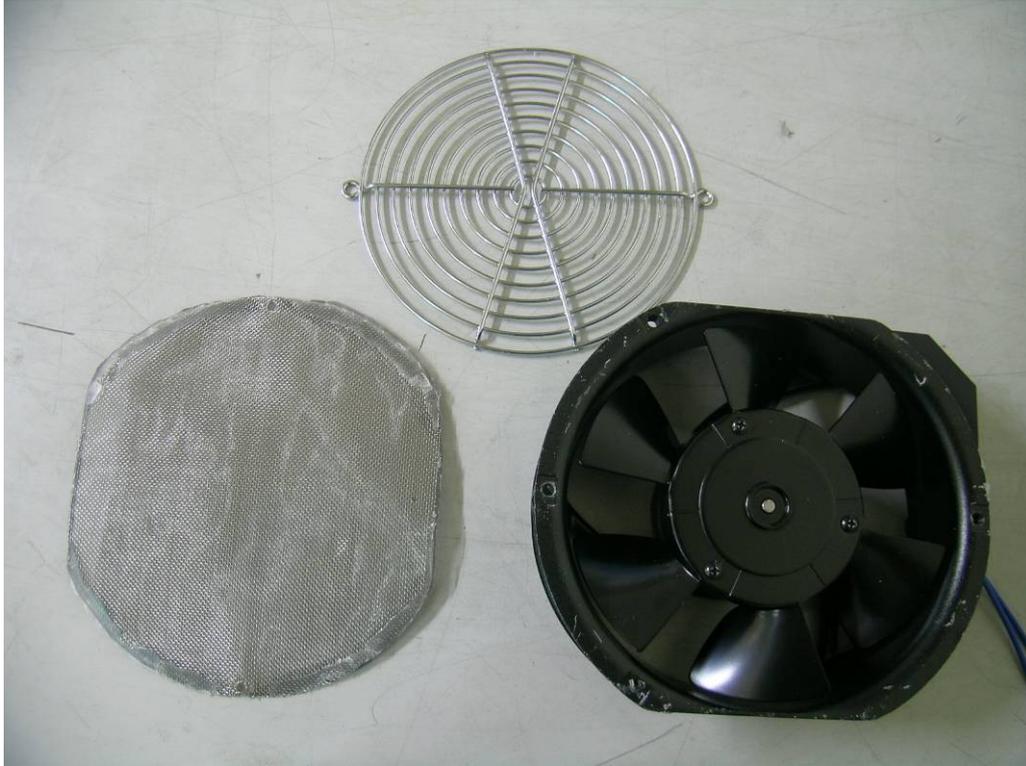
Axial fans (FDA2-17251) : Appearance

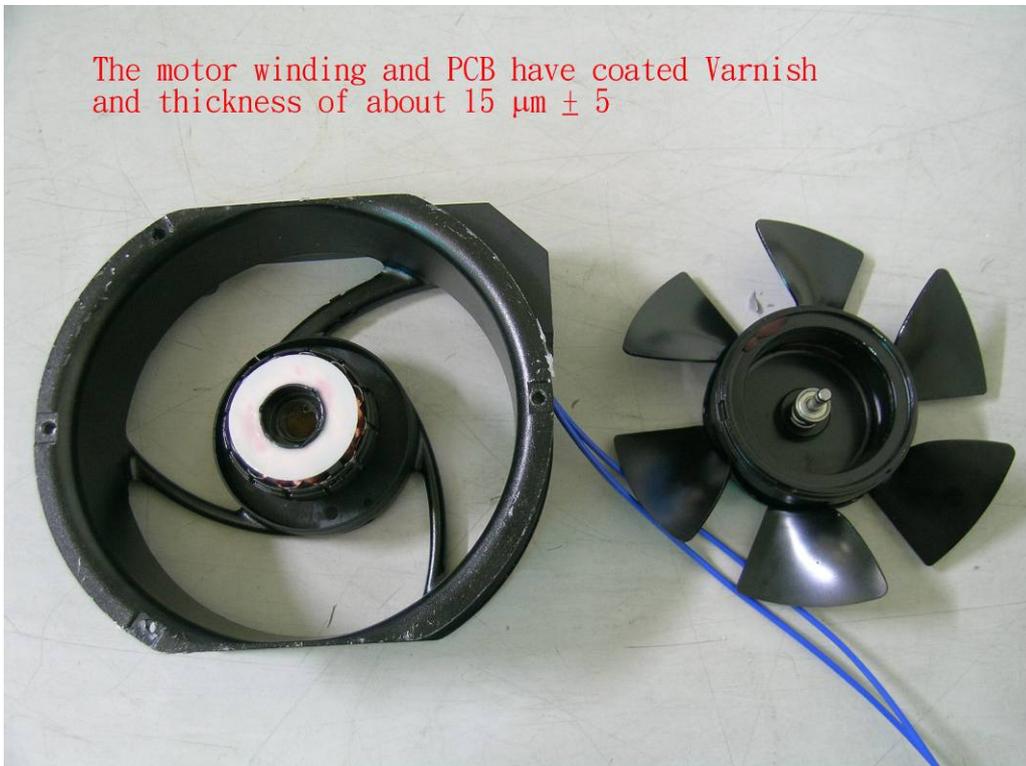
Axial fans (FDA2-17251) : Inside
