IHLP Standards of Manufacture

First Edition 2008
Rev

Vishay Electronics
Inductor Divisions

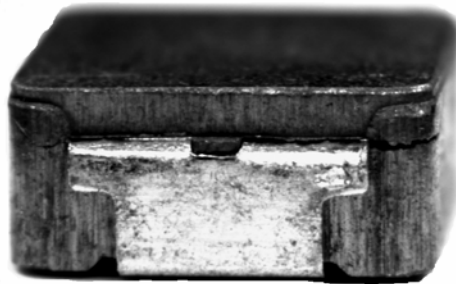
Terminal area crack, acceptable

Cracks coming from the top corner of the terminal are a normal occurrence and are caused by terminal expansion during curing operations.

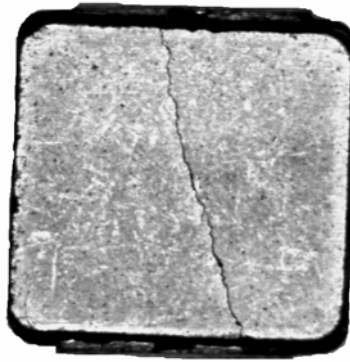
Moderate crack, rejectable

Moderate cracks are those that are obvious upon examination and continue across most of the component.

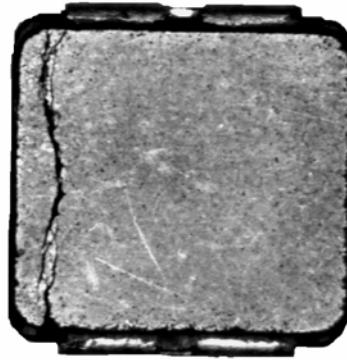
Major crack, rejectable

Major cracks are those that are obvious to a customer and would possibly result in large chip-outs that would expose the coil and lead frame.

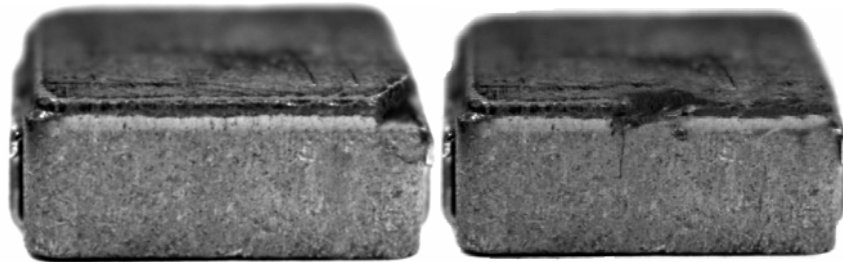
Minor Chipping, Acceptable

Minor chips in the inductor body are those that are typically shallow imperfections that occur on the corners and edge of components. No coil wire or lead frame is showing and the chip does not affect the performance or reliability of the component.

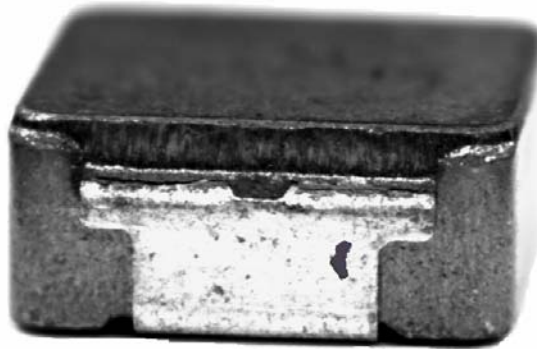
Foreign material may be seen pressed into the upper terminals. This material is of the same material as the inductor body and should not be a reason for rejection unless solderability is affected.

Foreign material: Acceptable
