Mechanical Cracking

The Major Cause for Multilayer Ceramic Capacitor Failures

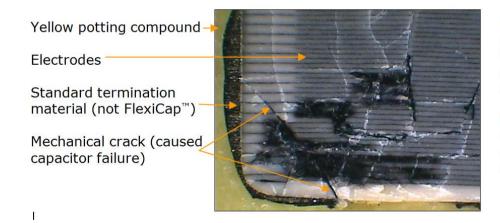
Figure 1: Mechanical Crack

Example of capacitors issued by customers to Syfer for failure investigation:

Black areas are damaged sections within the capacitor caused during the electrical failure

White lines are thermal cracks created during the electrical failure

When mechanical cracking has been identified as the cause for capacitor failures the typical approach for customers is to review the production process for any obvious process stage including handling and transportation that may be bending the PCB. If no obvious stage is identified then the next step is to remove samples of capacitors from assemblies at different process stages and then subject the capacitors to sectioning/ internal examination to determine if the capacitors have been cracked. The shape of mechanical cracks is shown in Fig.1.

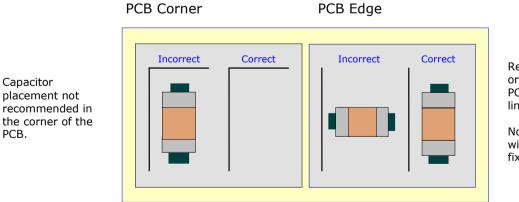
Recommended capacitor orientation with respect to PCB edge (denoted by black lines).

Note: Stress zone is typically within 5mm of PCB edge or fixing point.
