Ind. Ser. No. : 14-06-NEF-008

## TEST REPORT

| Products | : Axial fans |
| Testing Item | : IP54 |

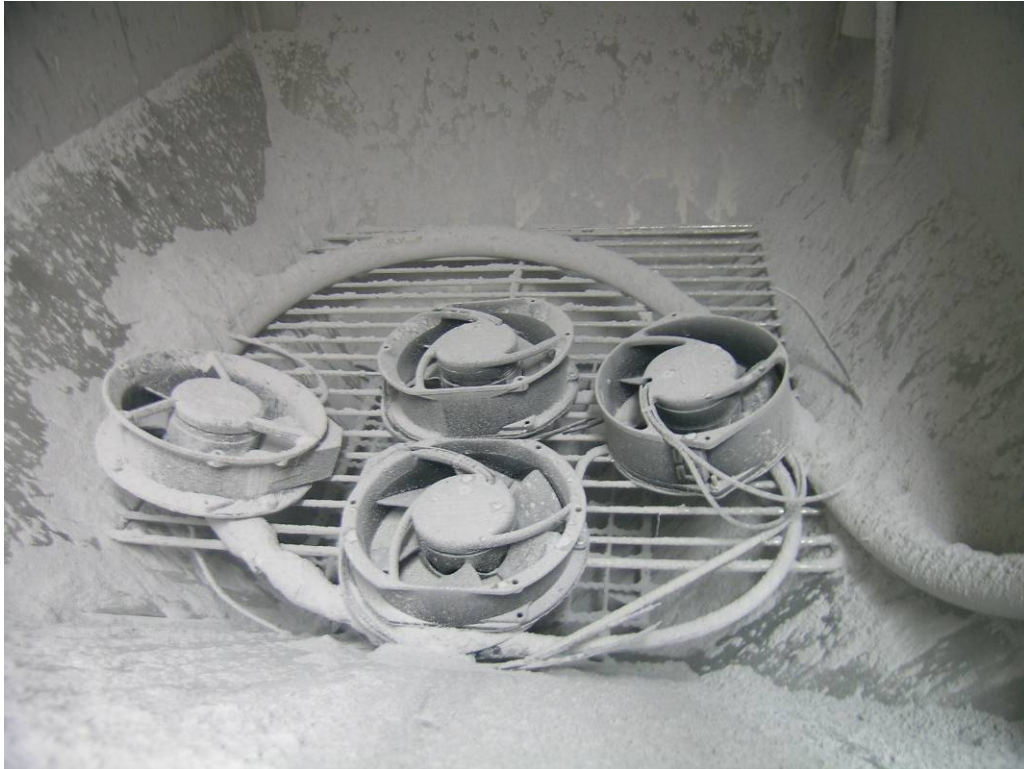
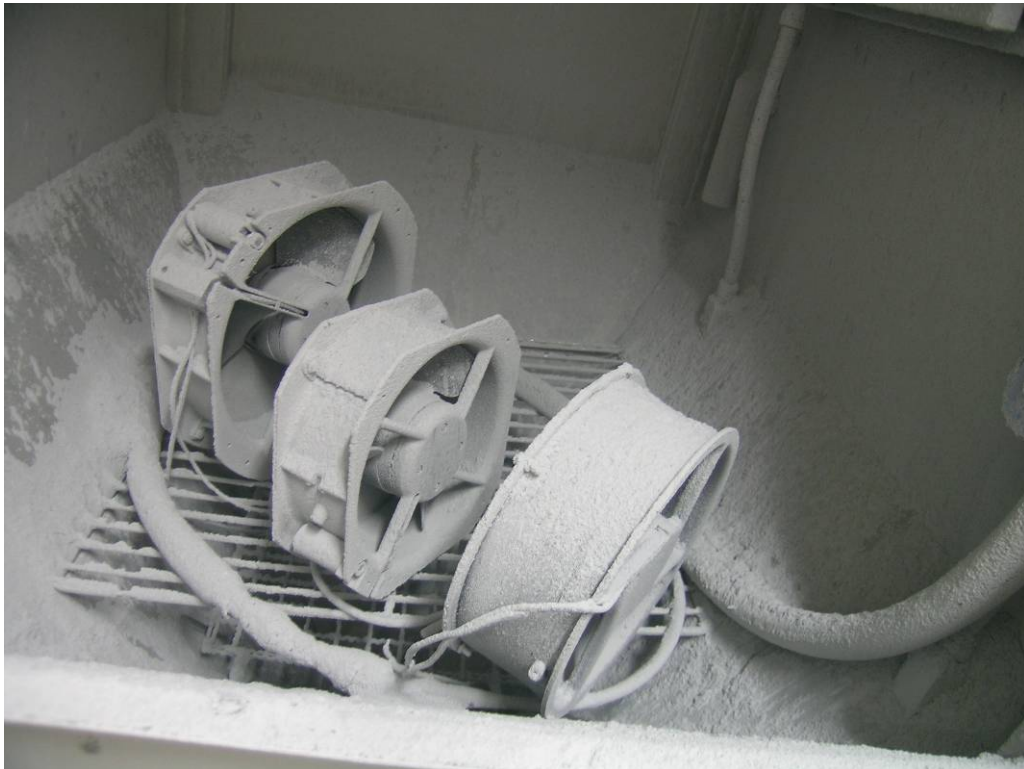
## Axial fans : IP5X Test Photo

#### (1) IP5X :

- (1) Maximum depression of 2kPa (20mbar) °
- (2) The test shall be continued for a period of 8 hours °

| Request/Experiment | Results | Remark |
|---|---|---|
| Accordance with IEC60529 13.1,13.4and 13.5 test.<br>The protection is satisfactory if, on inspection, talcum powder has not accumulated in a quantity or location such that, as with any other kind of dust, it could interfere with the correct operation of the equipment or impair safety. | There are some traces of dust inside, but not impaired safety. | IP5X |

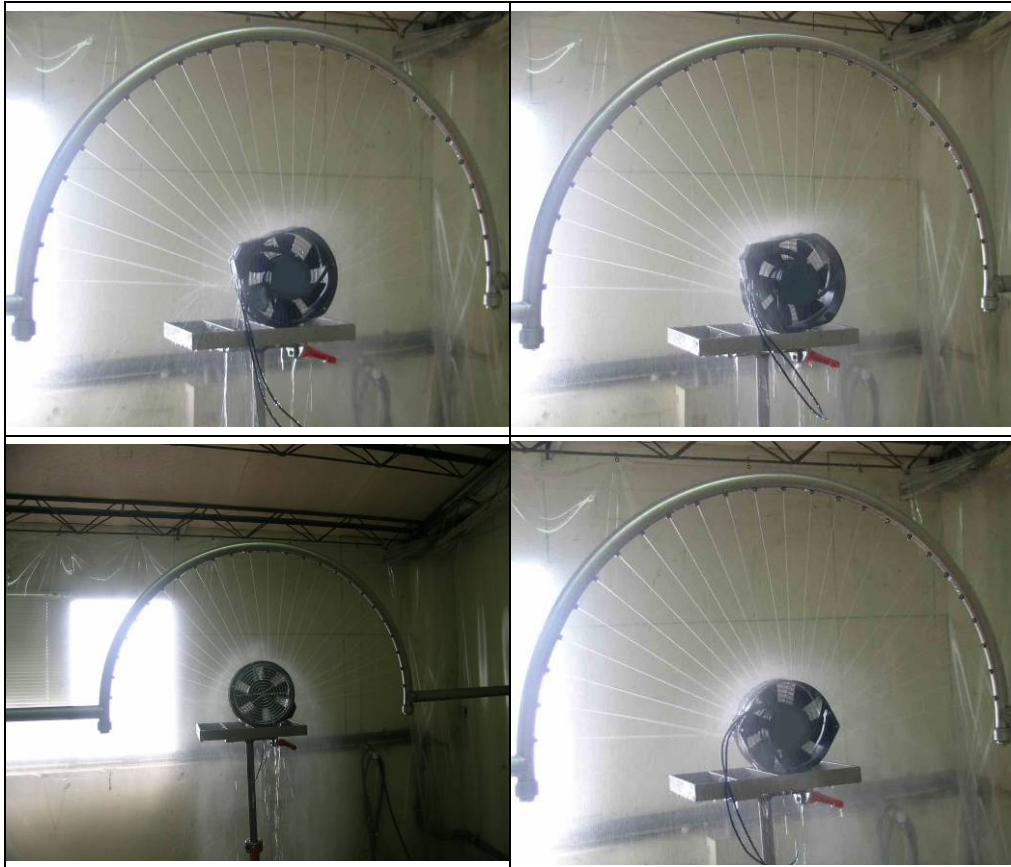
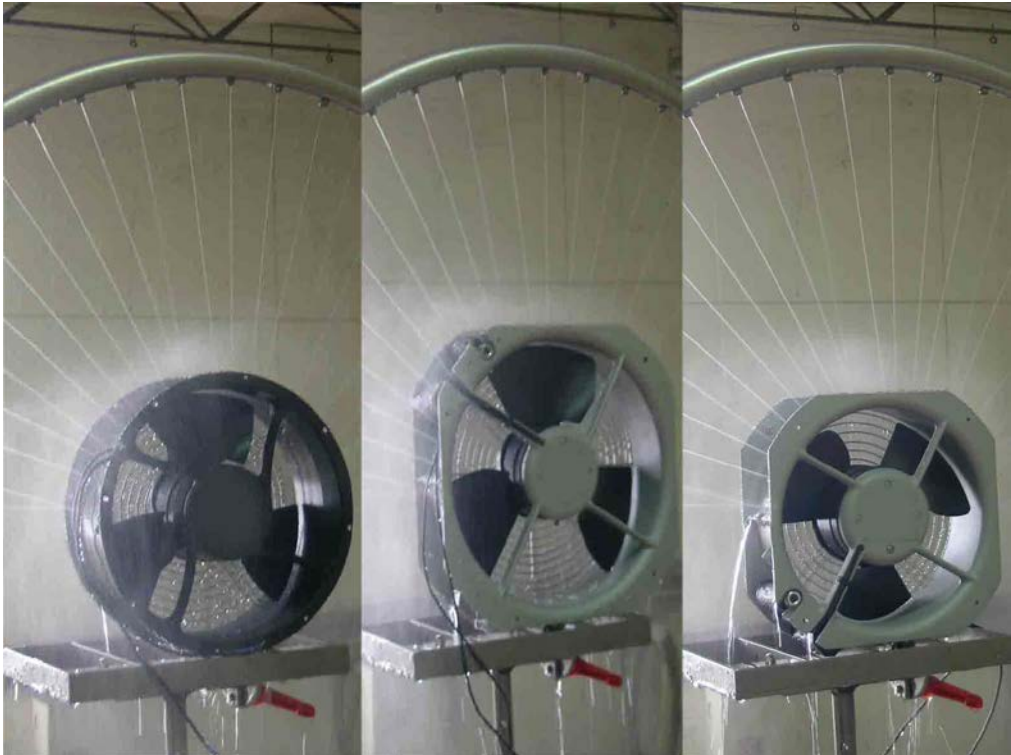
## Axial fans : IPX4 Test Photo

#### (2) IPX4 :

- (1) The oscillating tube has spray hole over the whole 180° of the semicircle .
- (2) The tube is caused to oscillate through an angle of almost 360° , 180° on either side of the vertical , the time for one complete oscillation ( 2×360° ) be
- (3) The duration of the test is 10 min.
- (4) Mean flow rate per hole  $qv1=0.07 \text{ l/min}$

| Request/Experiment | Results | Remark |
|---|---|---|
| After testing in accordance with appropriate requirements of IEC60529 14.1,14.2.4 and 14.3 | There are some traces of water inside, but not impaired safety. | IPX4 |

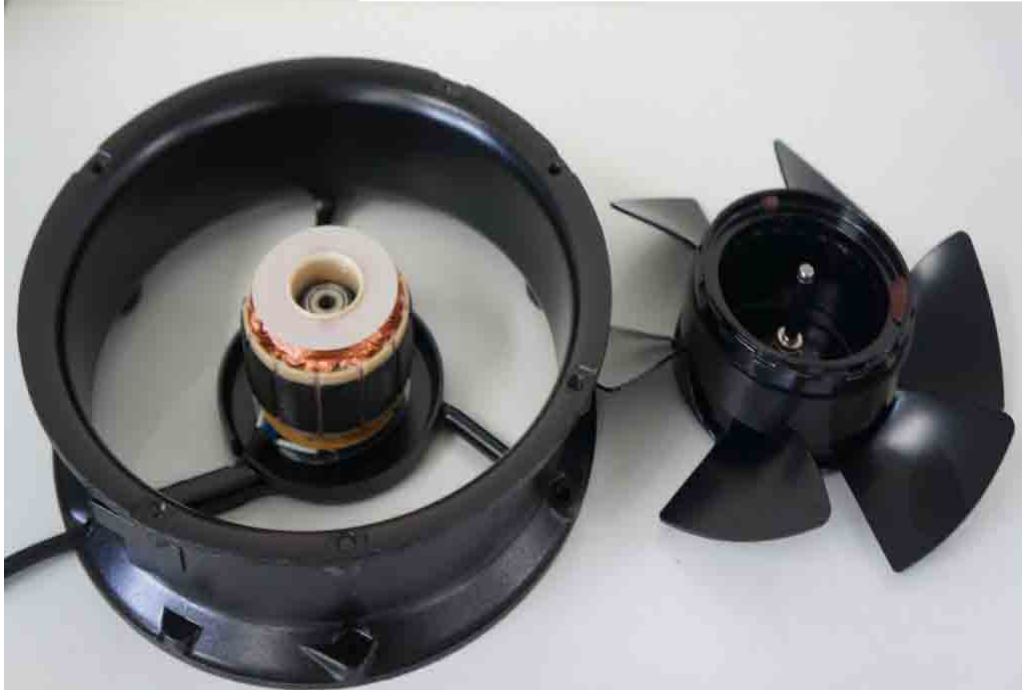
**Inside : FDA2-17251xxxx4F (round)**

The motor winding and PCB have coated Varnish  
and thickness of about  $15 \pm 5 \mu\text{m}$ .

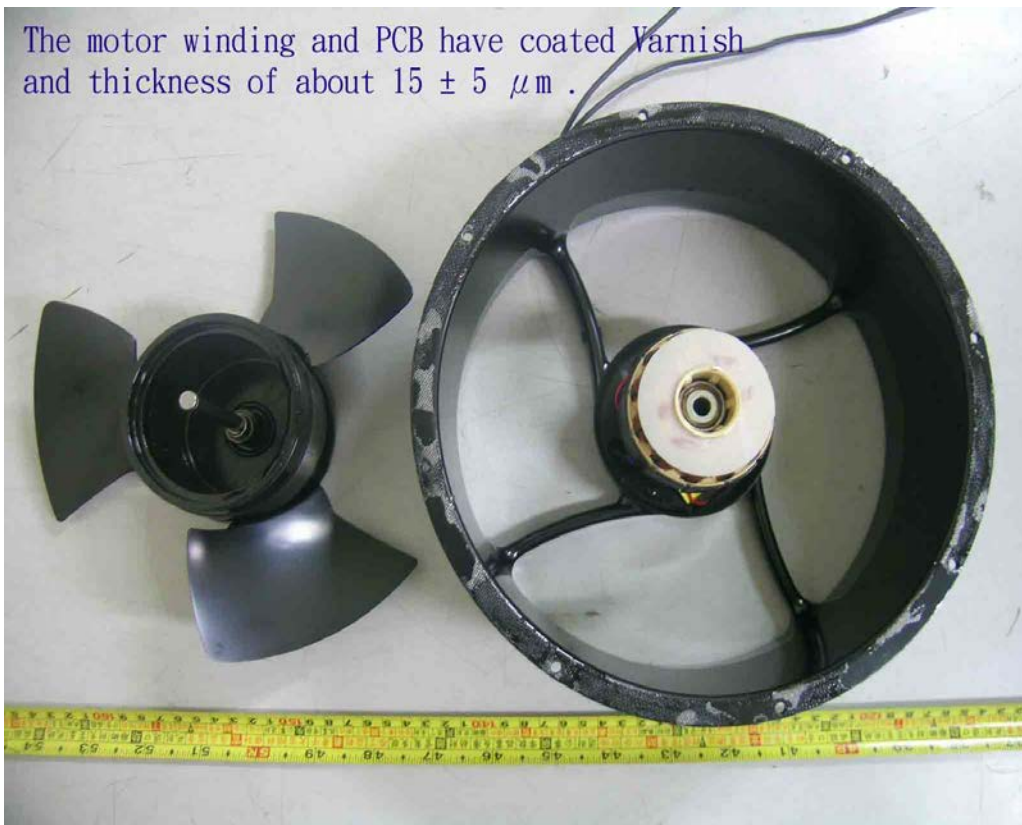
**Inside : FDA2-25489xxxx4F**

The motor winding and PCB have coated Varnish  
and thickness of about  $15 \pm 5 \mu\text{m}$ .
