AD9516 DEBUG PROCEDURE STEP BY STEP

This note will help engineer to debug AD9516 step by step to try to identify which circuit that results in the “ad9516 has no output”.

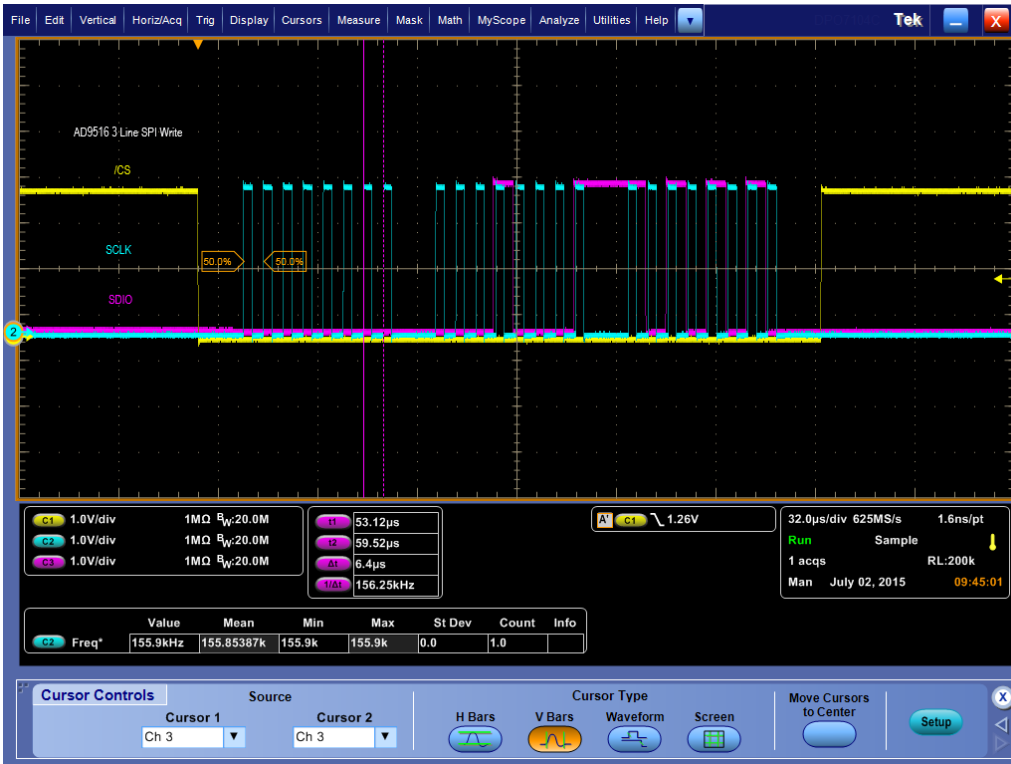
1. SPI Timing- 3 Line SPI Write REG0x11=0xAA

Total 24 SCLK cycles in one /CS low period: 0, 1, 2, ..., 23. On each rising edge of SCLK, AD9516 samples SPI command (address+data).

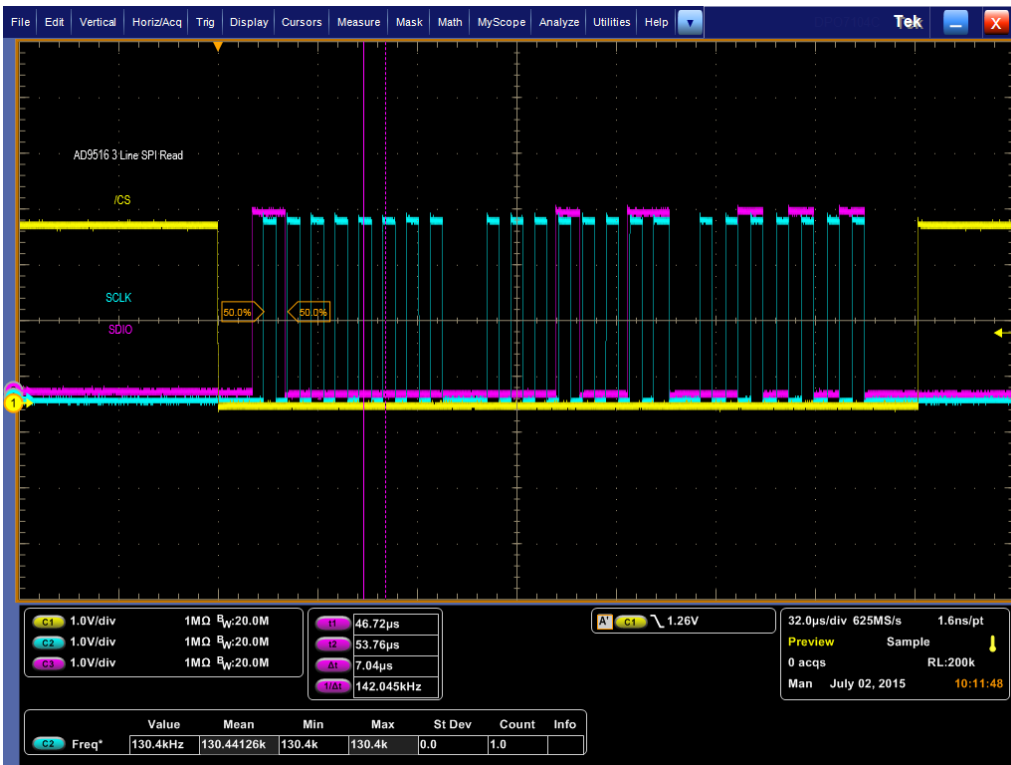
2. SPI Timing- 3 Line SPI Read REG0x11=0xAA

Total 23 SCLK cycles in one /CS low period, 0, 1, 2, ..., 22. On the 15th falling edge of SCLK, AD9516 output data[7] via SDIO, On the 22th falling edge of SCLK, AD9516 output data[0] via SDIO.

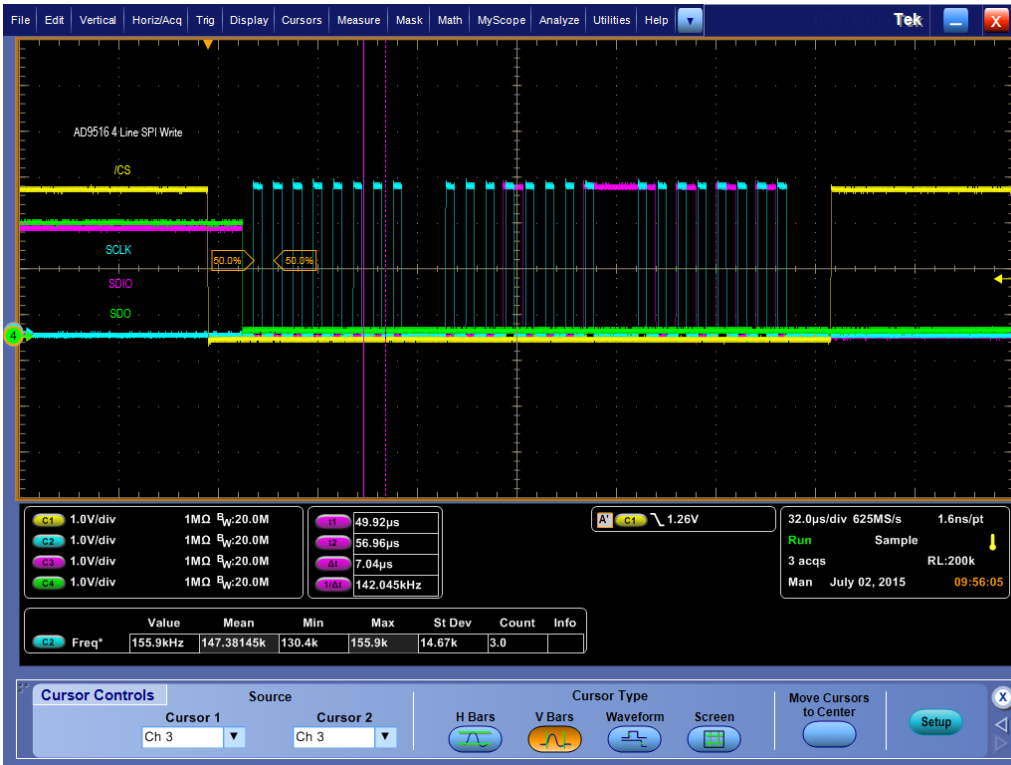
3. SPI Timing- 4 Line SPI Write REG0x11=0xAA

Total 24 SCLK cycles in one /CS low period: 0, 1, 2, ..., 23. On each rising edge of SCLK, AD9516 samples SPI command (address+data).
